THE EFFECT OF MULTIPLE WELD REPAIRS
ON THE FATIGUE RESISTANCE OF
WELDED ALUMINUM ALLOY 5083-0

THESIS

The Effect Of Multiple Weld Repairs
On The Fatigue Resistance Of
Welded Aluminum Alloy 5083-0

December 1979

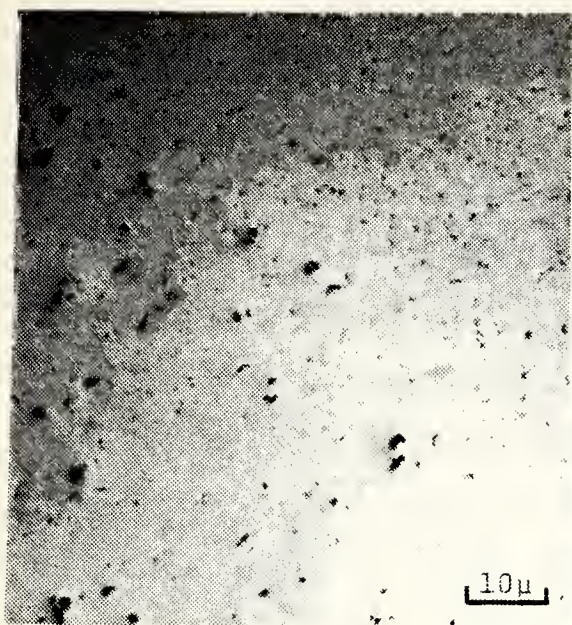
Figure 10. Photographs taken of the "as-polished" specimen subjected to 16 repair simulations. The locations represented are the interface (a), approximately 6 mm (b), 18 mm (c) and 27 mm (d) from the interface. (100X)

Lt. G.R. Speight's research in this area disclosed that the insoluble inclusions $(\text{FeMn})_3 \text{SiAl}_{12}$ and Mg_2Si grew and coarsened with increasing numbers of weld repairs [27]. Figures 9 and 10 illustrate this coarsening. Figure 9 shows micrographs of an as-polished specimen subjected to the original two-pass weld only. Figure 10 shows micrographs of an as-polished specimen subjected to sixteen repair simulations. This coarsening had little apparent effect on tensile strength, stress corrosion cracking susceptibility and hardness, although, as noted previously, there was a slight tendency toward degradation in these properties.

Summarized in Section II above. Figures 9 and 10 illustrate the microstructure.

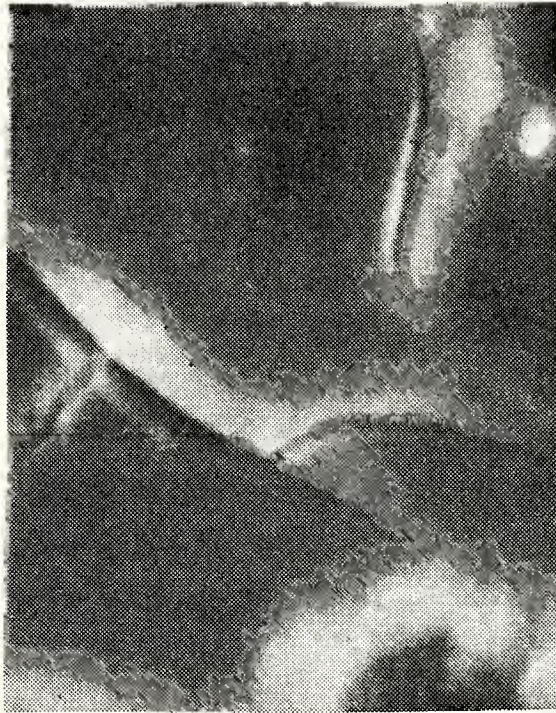
Figure 11 (c). Fourteen weld repaired specimen in the as-polished condition. Photograph taken on the SEM. (7000X). Cracks have developed in the inclusions.

(c) Fourteen weld repaired specimen in the as-polished condition. Photograph taken on the SEM. (7000X). Cracks have developed in the inclusions.
12. S-N Fatigue Diagram for AL 5083-0 original plate. σ_{MAX} on the haversine loading curve is plotted on the vertical axis while cycles to failure, N, is plotted on the horizontal axis.
13. S-N Fatigue Diagram for AL 5083-0 which has been weld repaired twice. σ_{MAX} on the haversine loading curve is plotted on the vertical axis while cycles to failure, N, is plotted on the horizontal axis.
14. S-N Fatigue Diagram for AL 5083-0 which has been weld repaired fourteen times. σ_{MAX} on the haversine loading curve is plotted on the vertical axis while cycles to failure, N, is plotted on the horizontal axis.

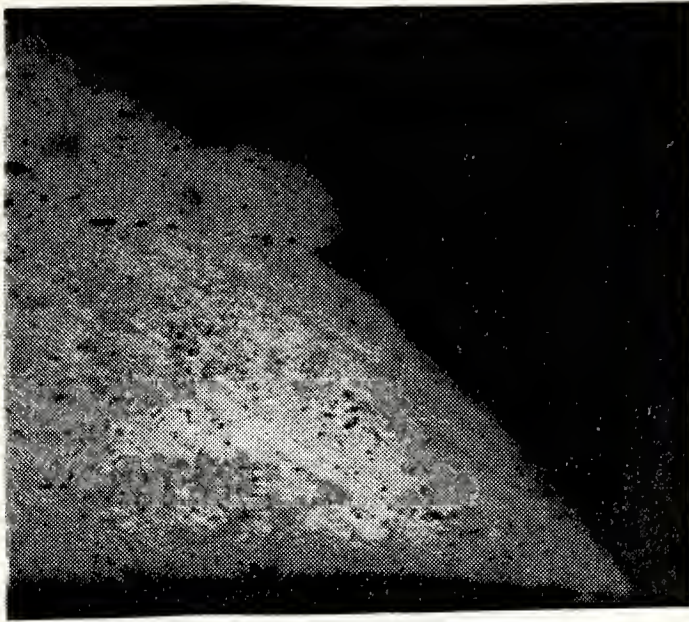
Figure 20. Observation of transverse section of the fracture surface. (100X). The specimen is from an original plate. Note the absence of porosity.

19. The fatigue zone of Figure 18 at a magnification of 51 diameters.
20. Observation of transverse section of the fracture surface. (100X). The specimen is from an original plate. Note the absence of porosity.
